**CALSPAN ON-SITE AIR BAG/CHILD FATALITY INVESTIGATION**

**CALSPAN CASE NO. 96-15**

**VEHICLE - 1995 MAZDA PROTÉGÉ'**

**LOCATION - OHIO**

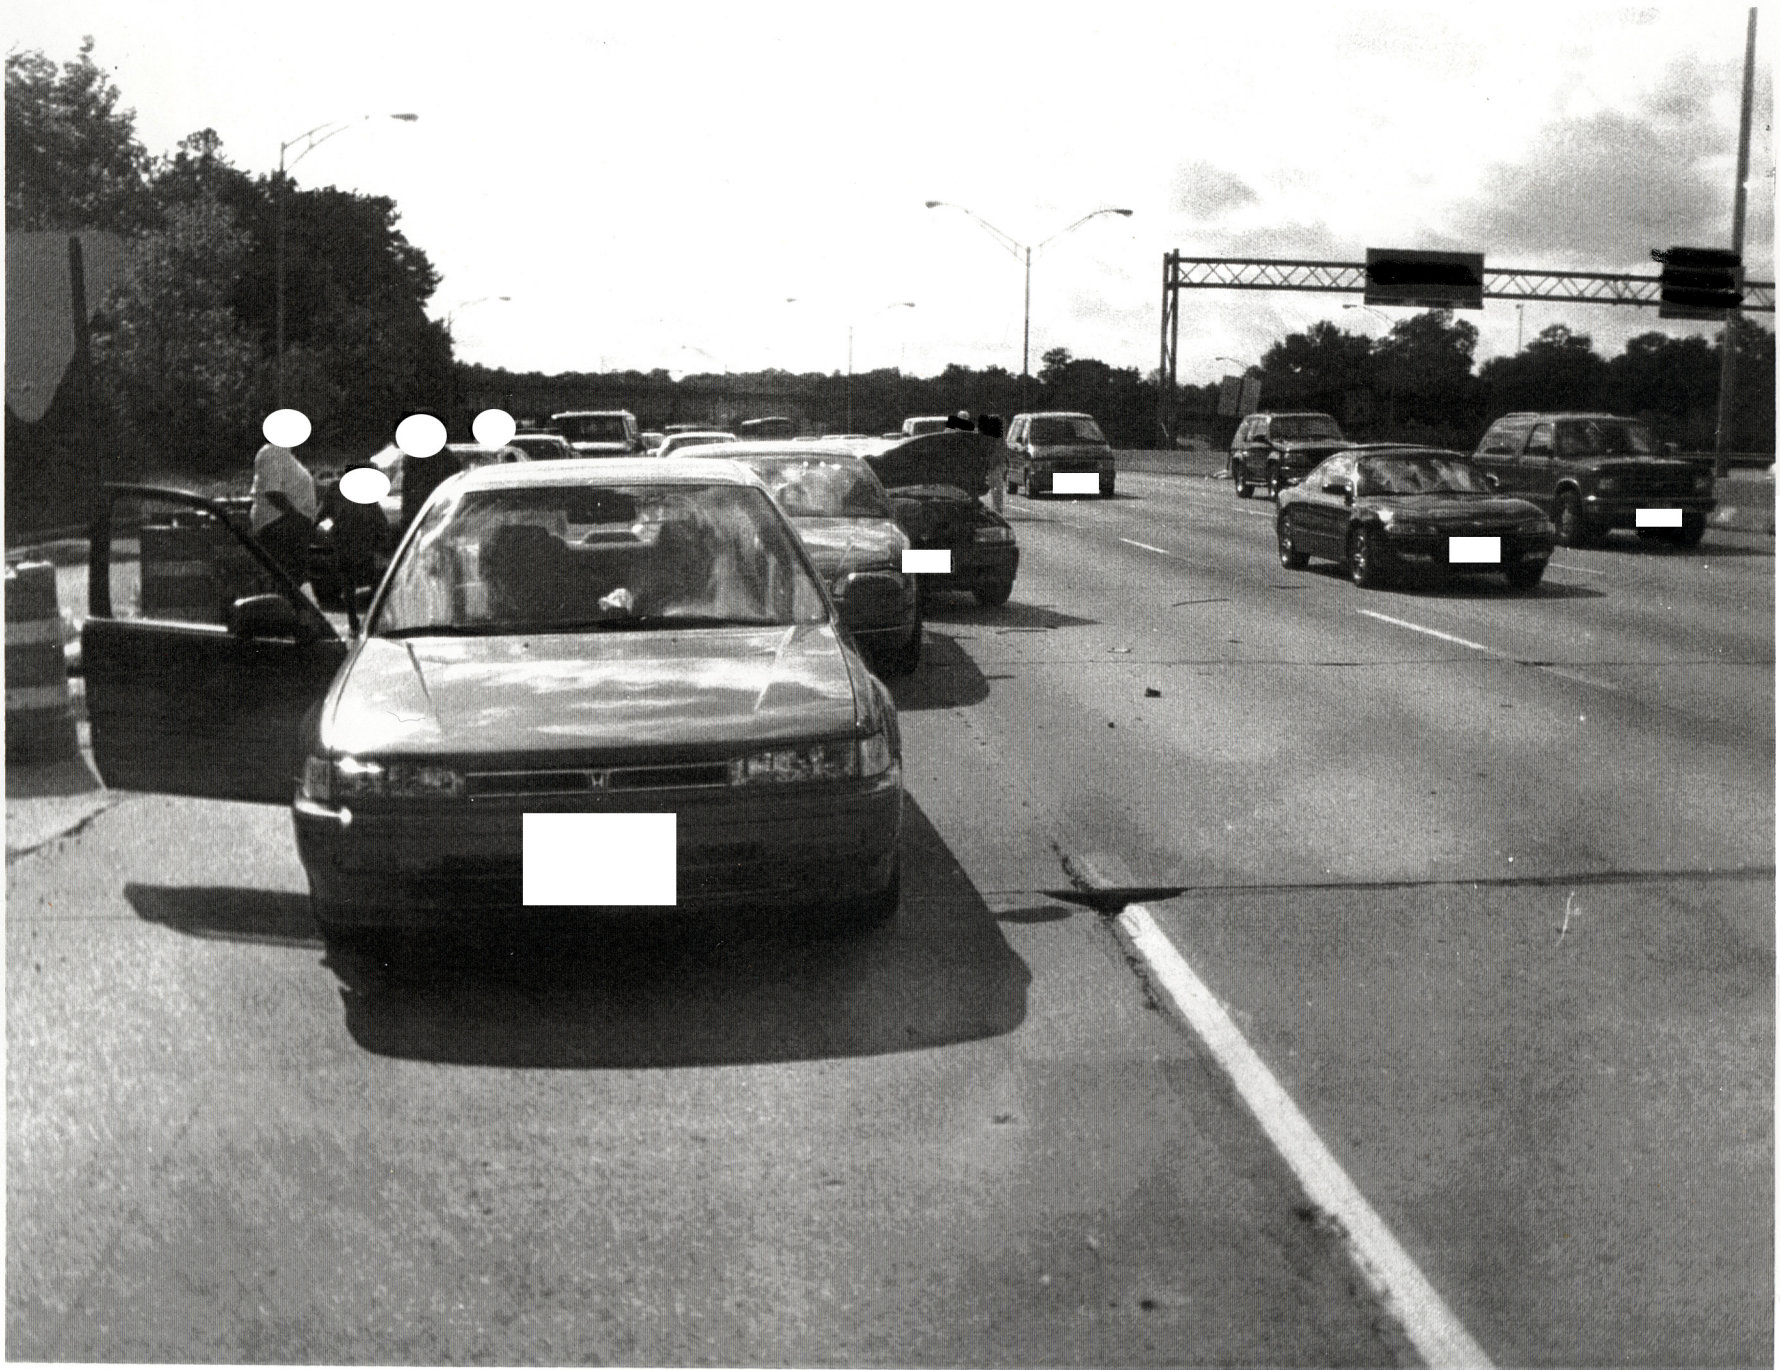
3. Look back view of the FRP.

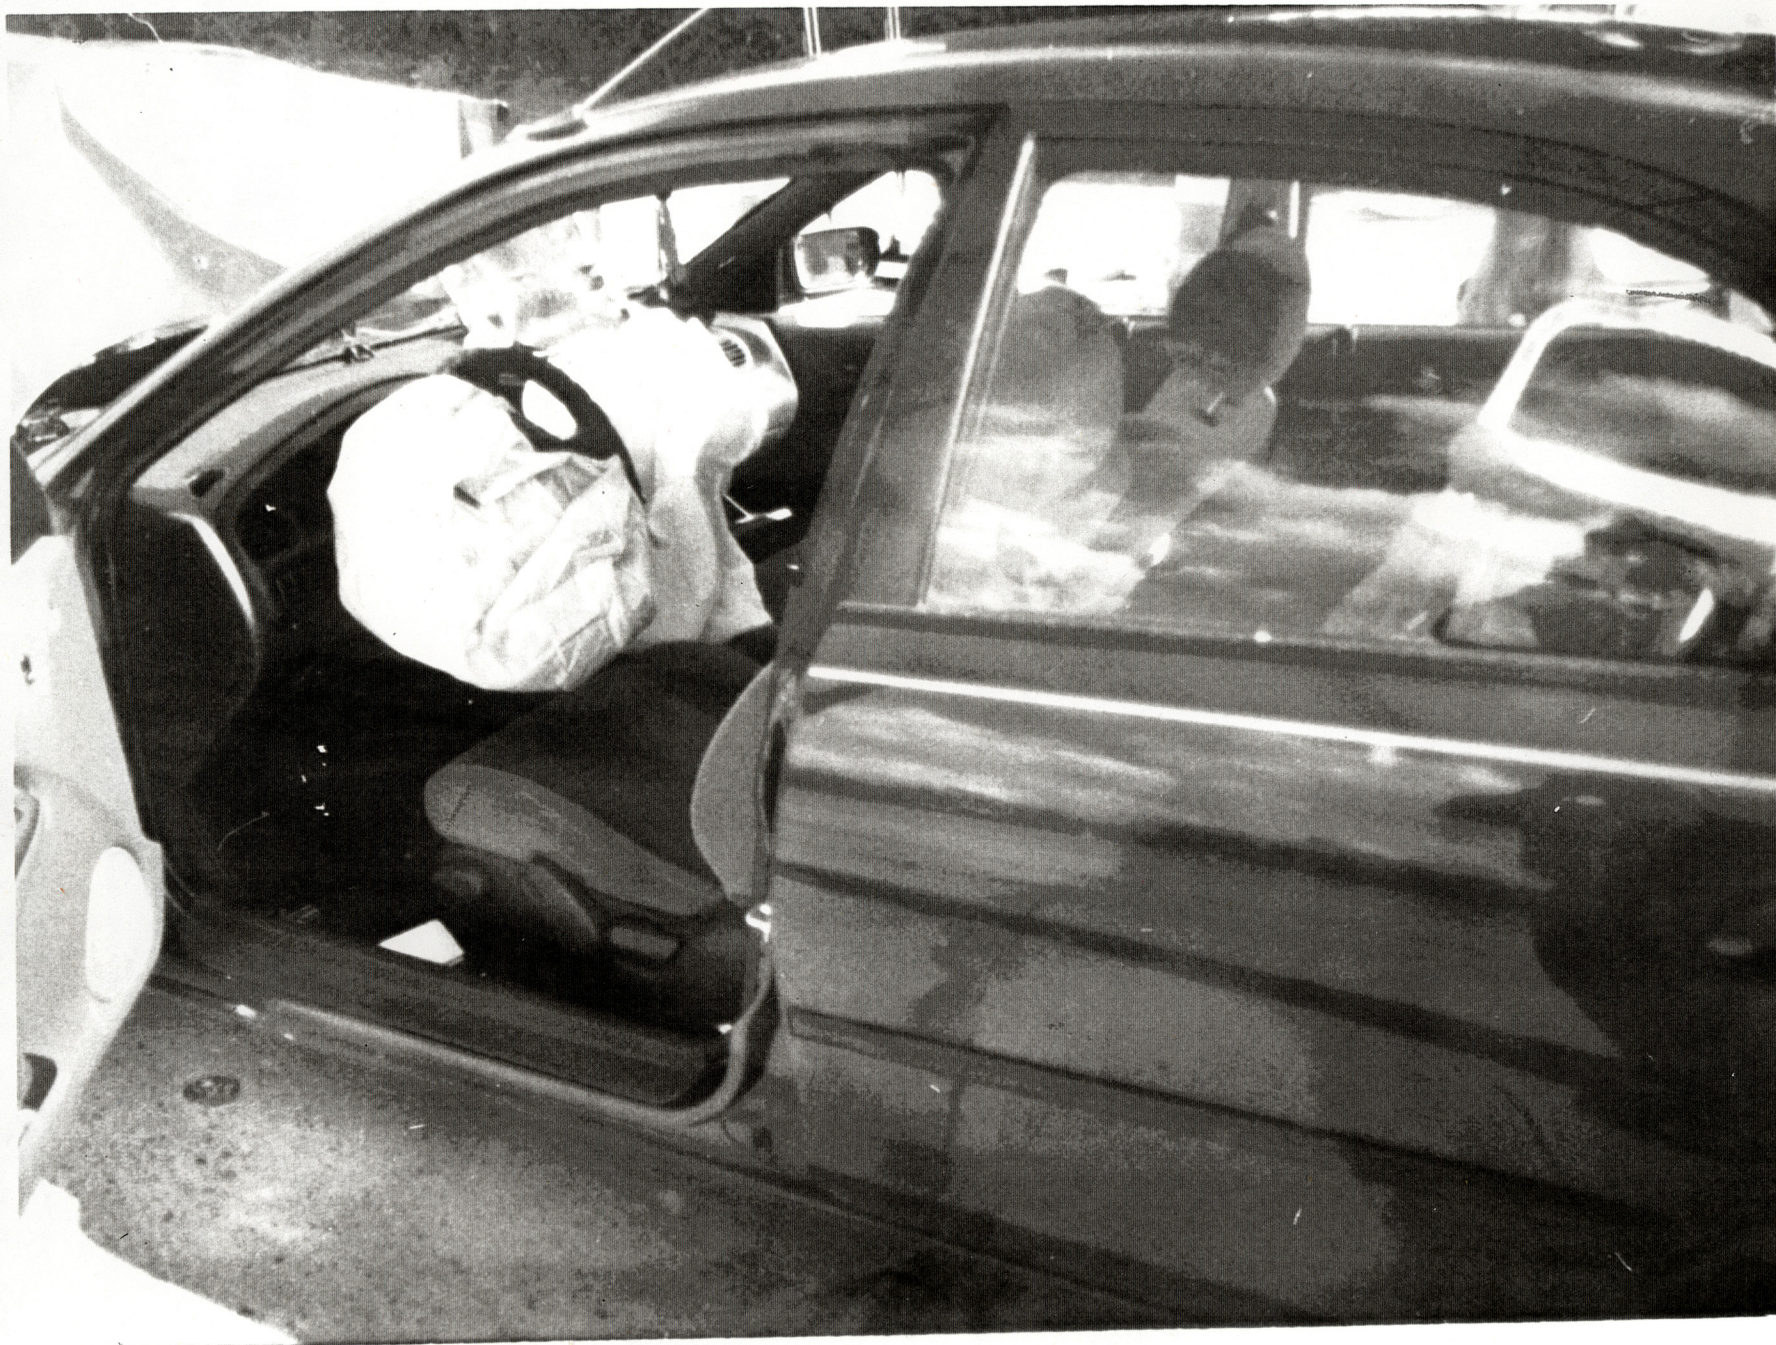
5. Left forward interior view of the Mazda at the FRP.

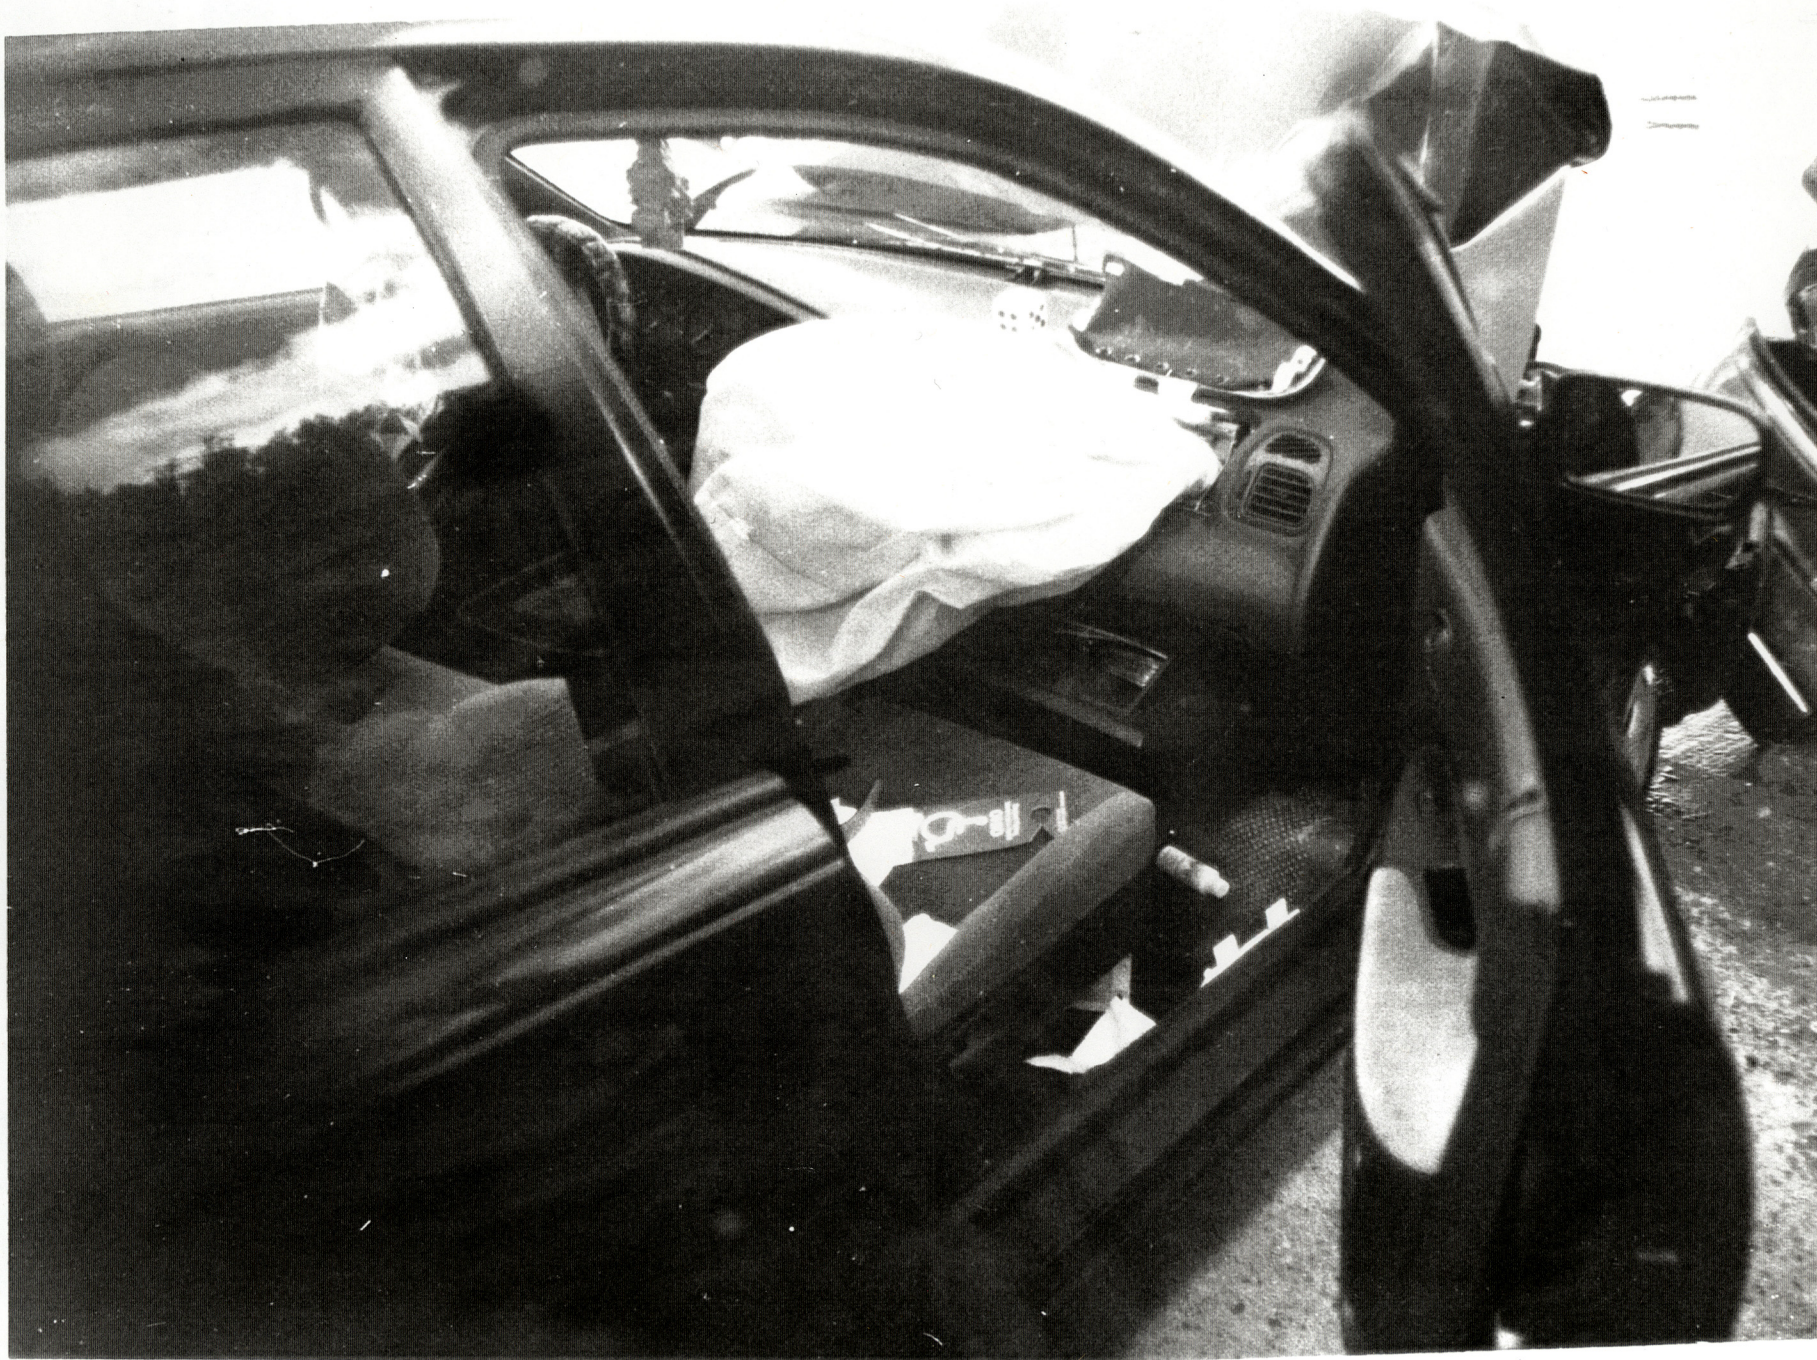
6. Right forward interior view of the Mazda at the FRP.

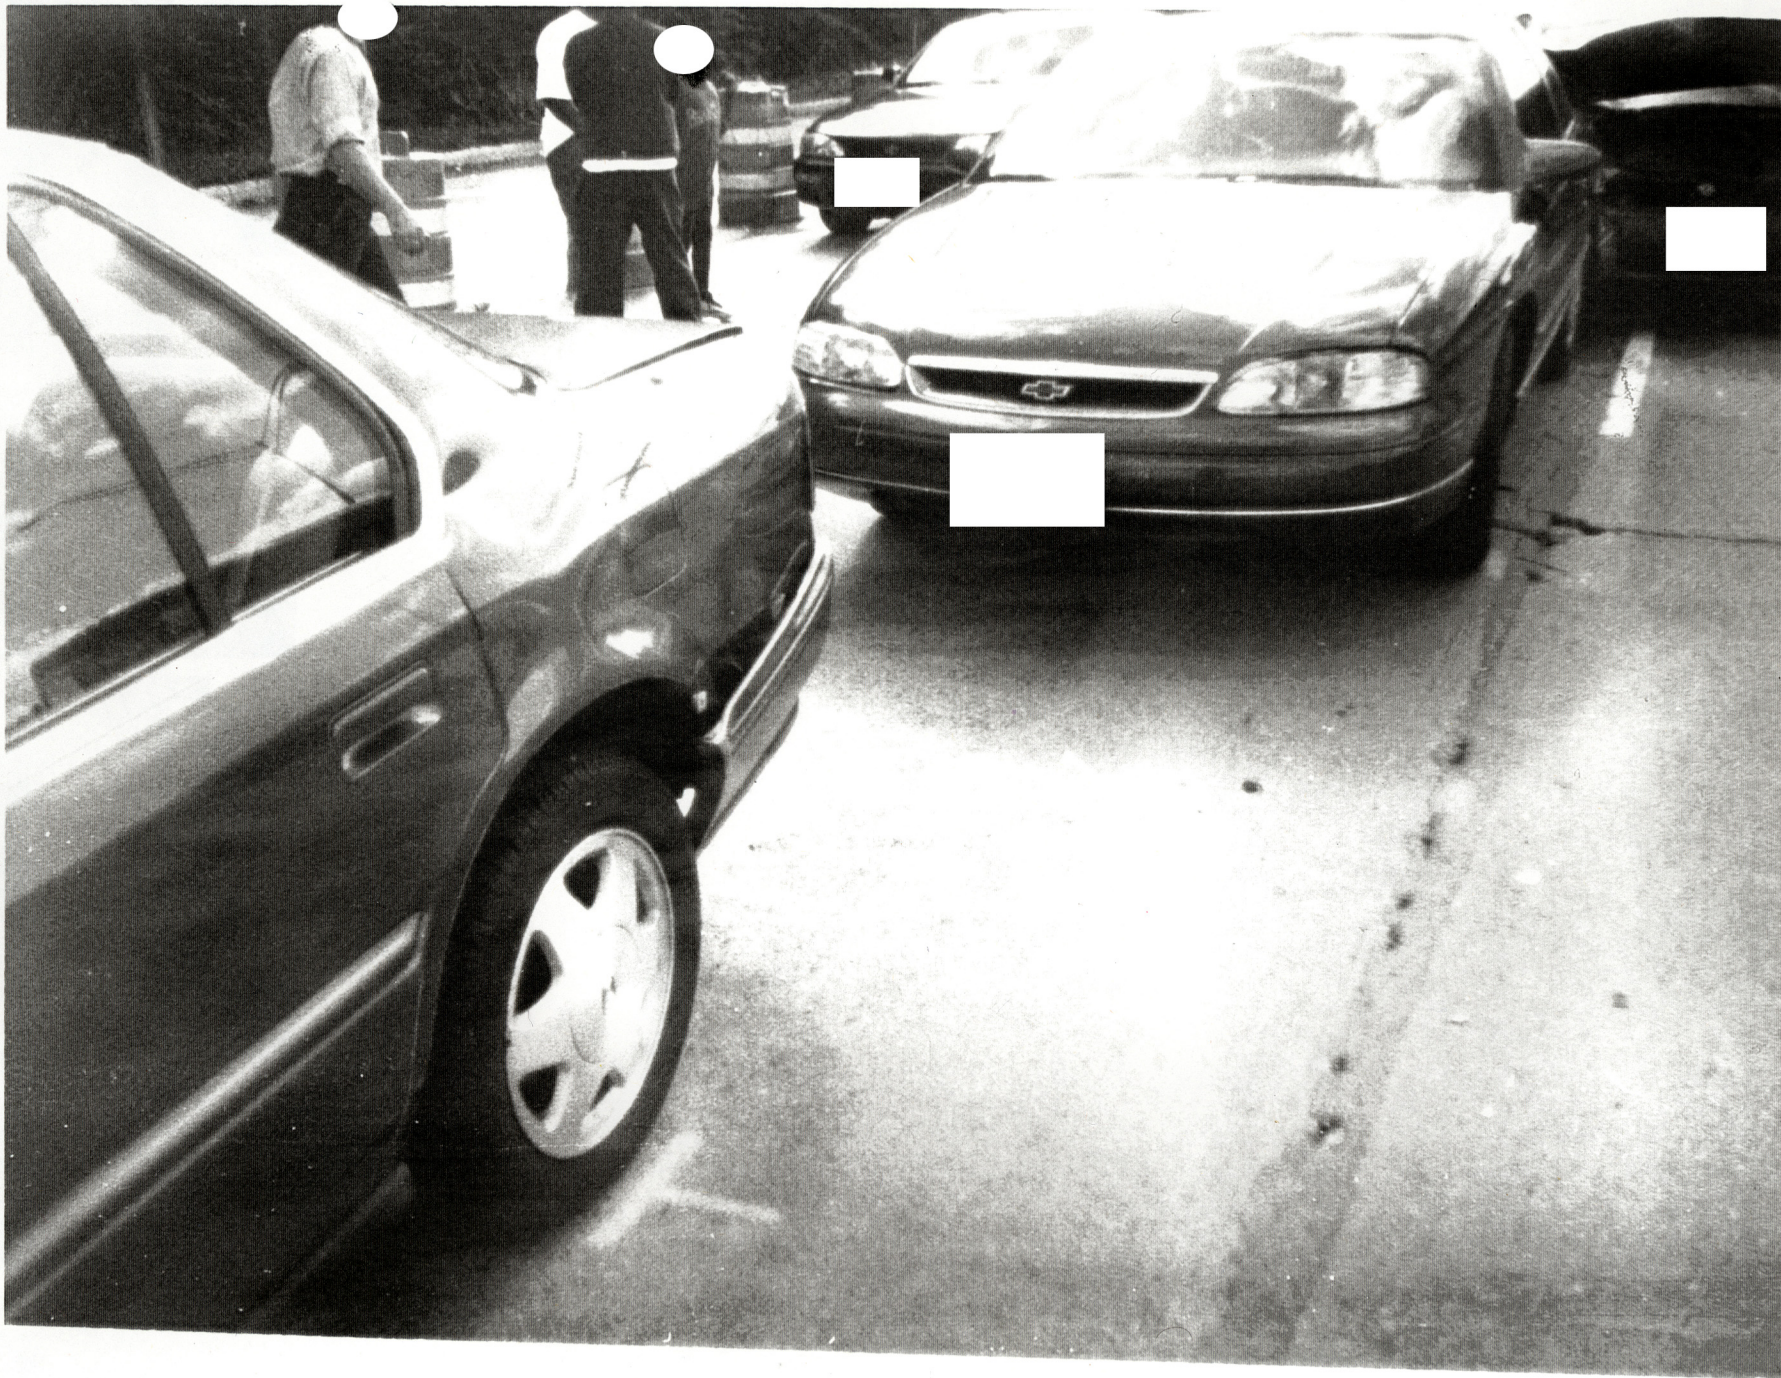
7. View of the FRP of the 1993 Honda Accord and the 1995 Chevrolet Monte Carlo.

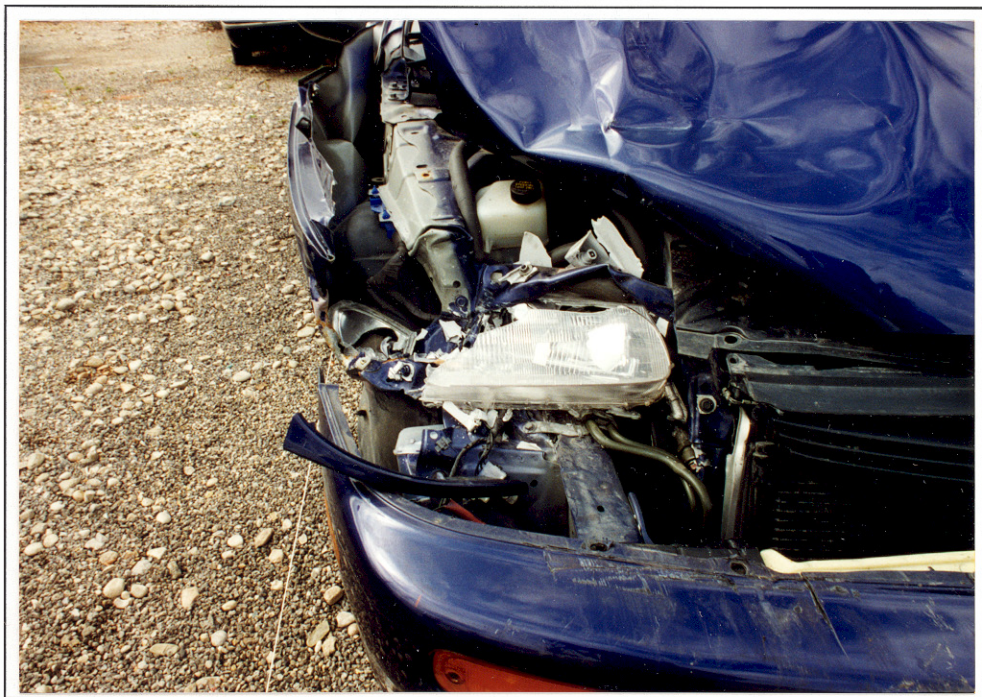
3. Close-up view of the right front damage.

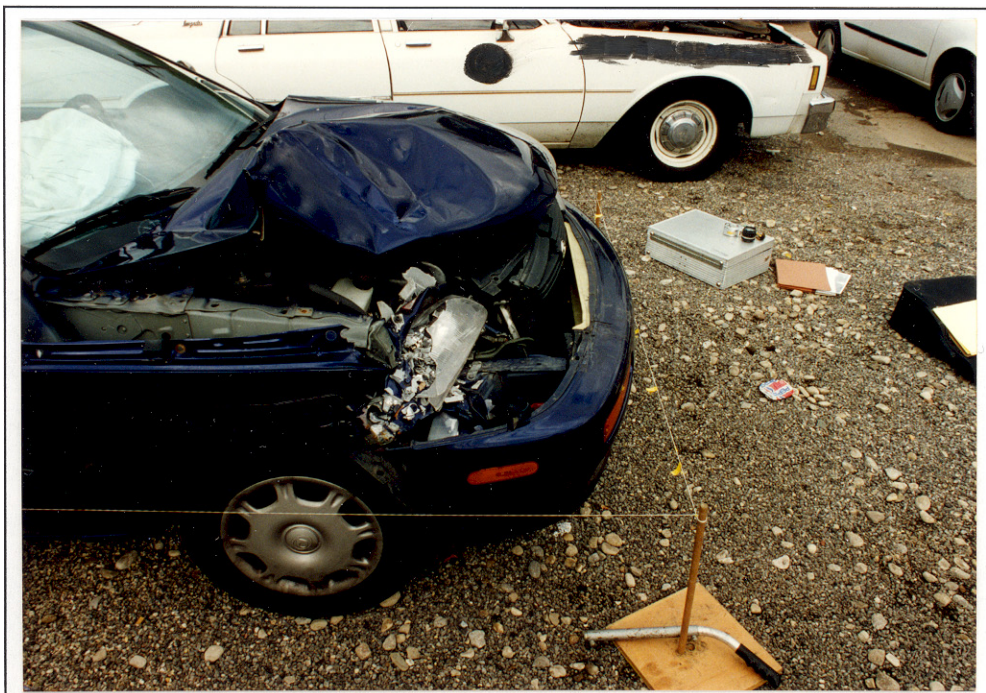
12. Right lateral view of the frontal damage.

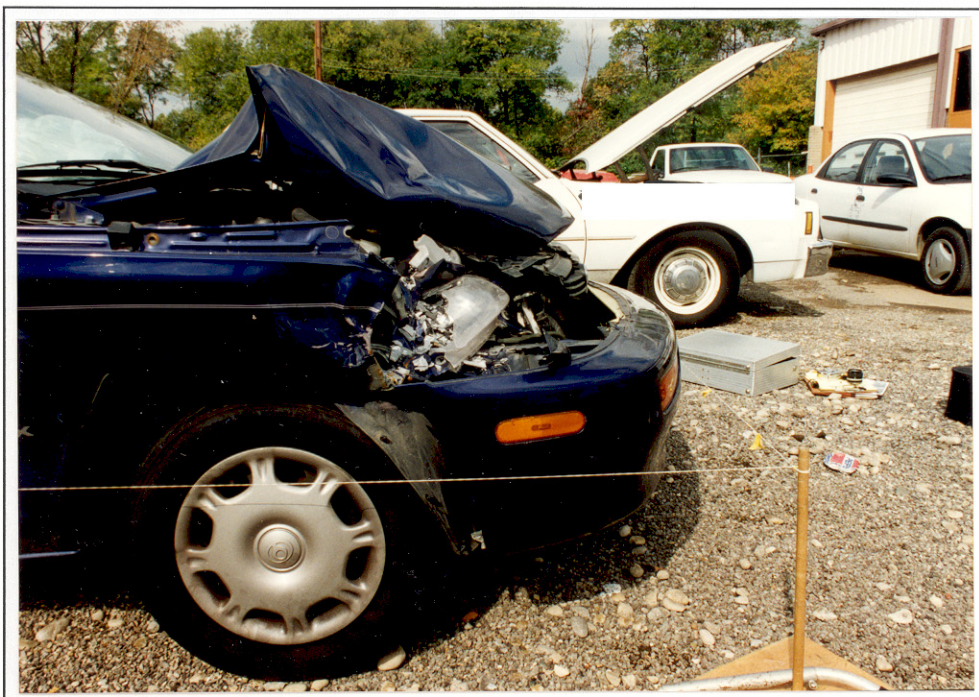
13. Close-up view of the right front damage.

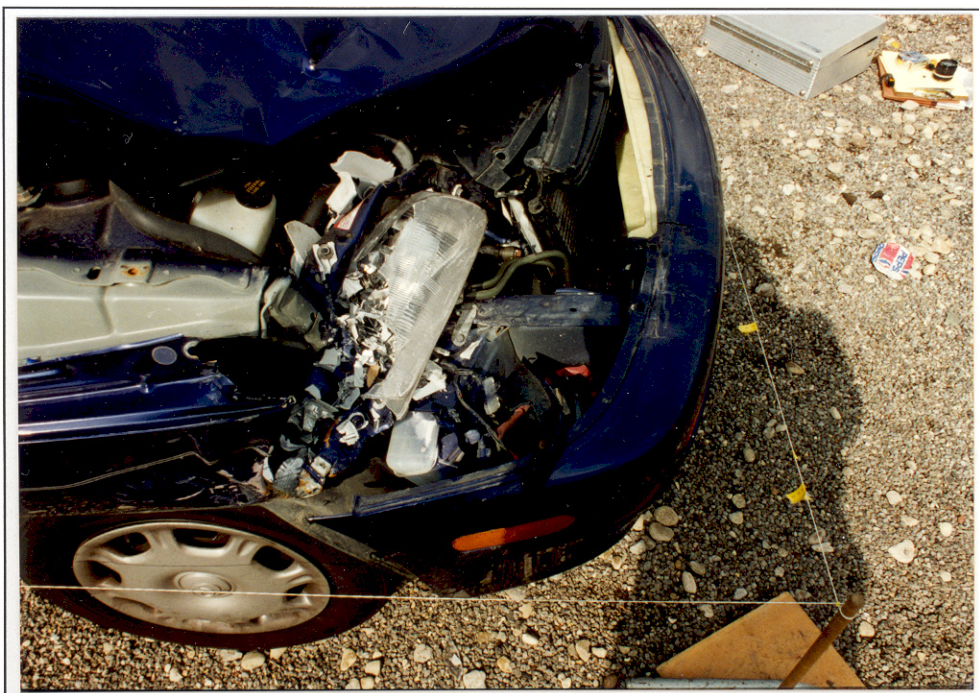
14. Close-up view of the right front damage.

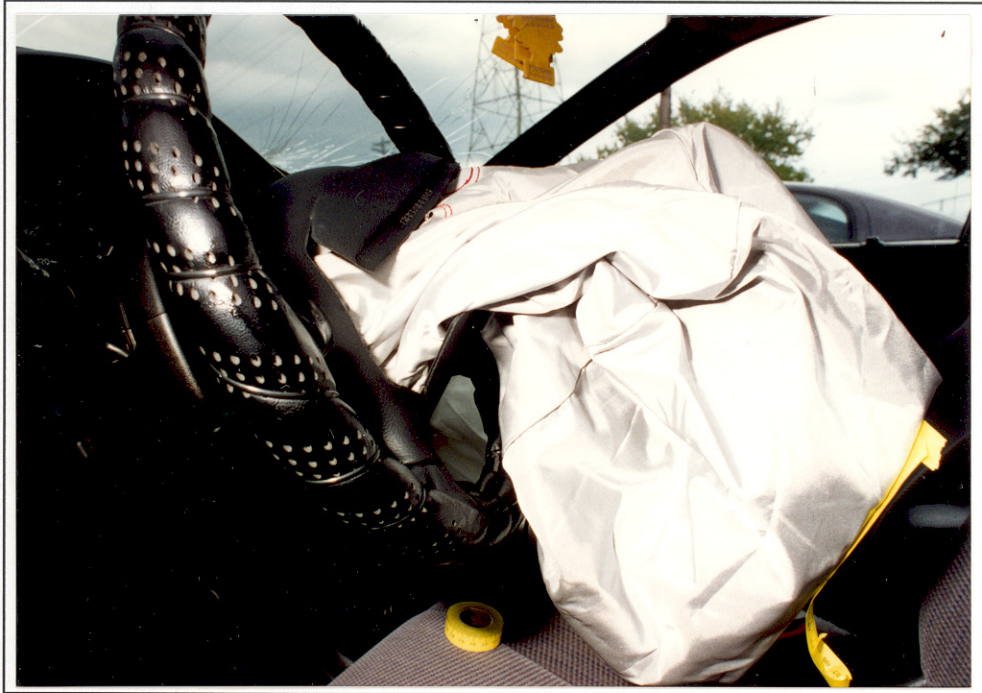
21. View of the deployed air bag and cover flaps.

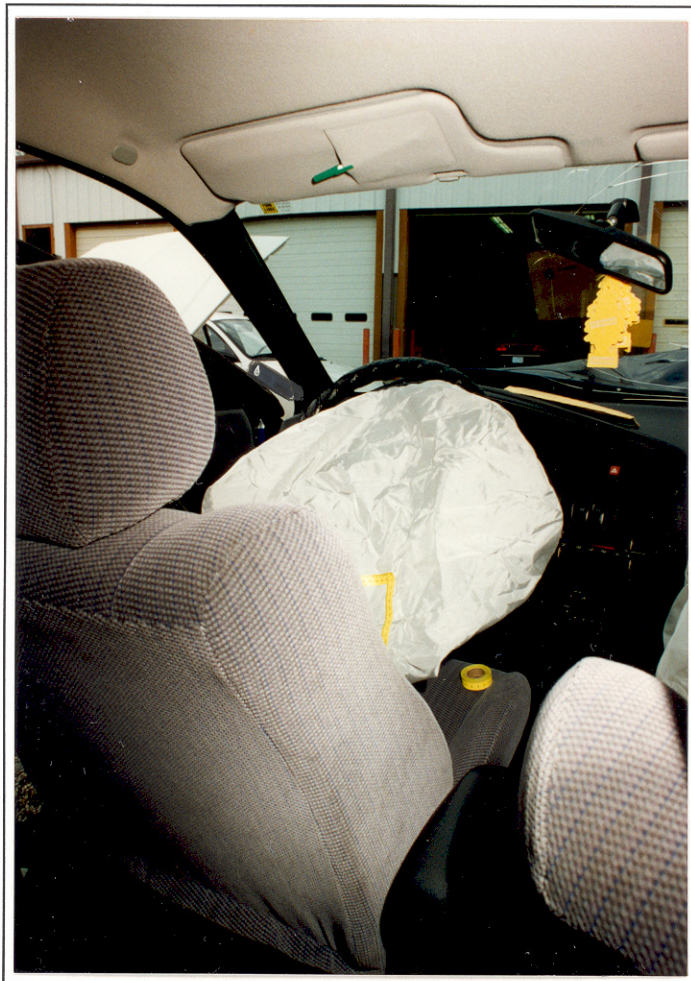
23. Angular view of the left front interior and deployed driver side air bag.

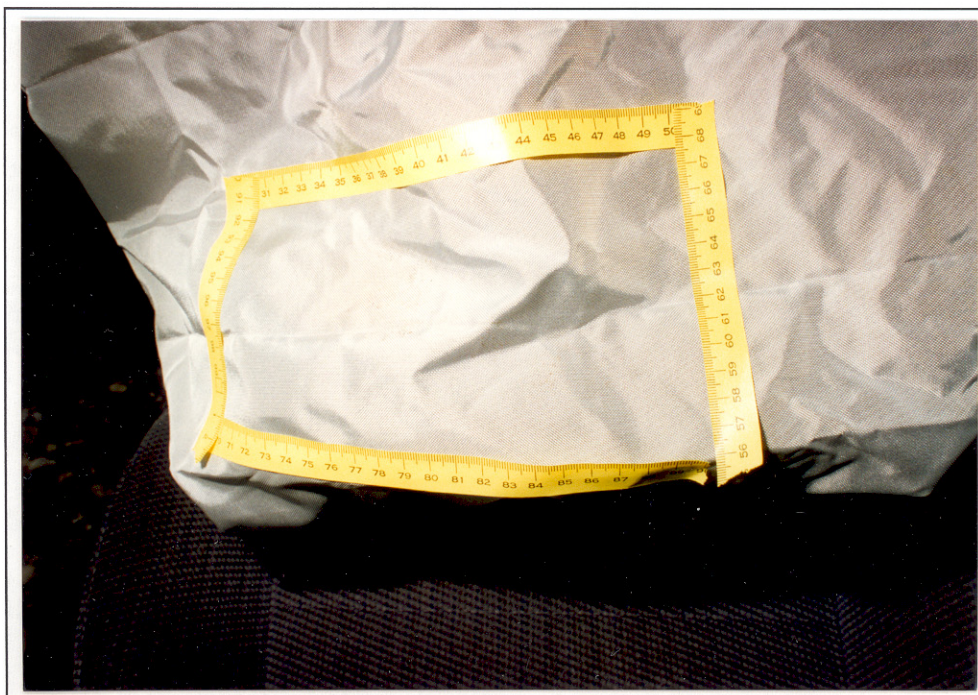
26. Close-up view of a tissue transfer on the lower left quadrant of the air bag.

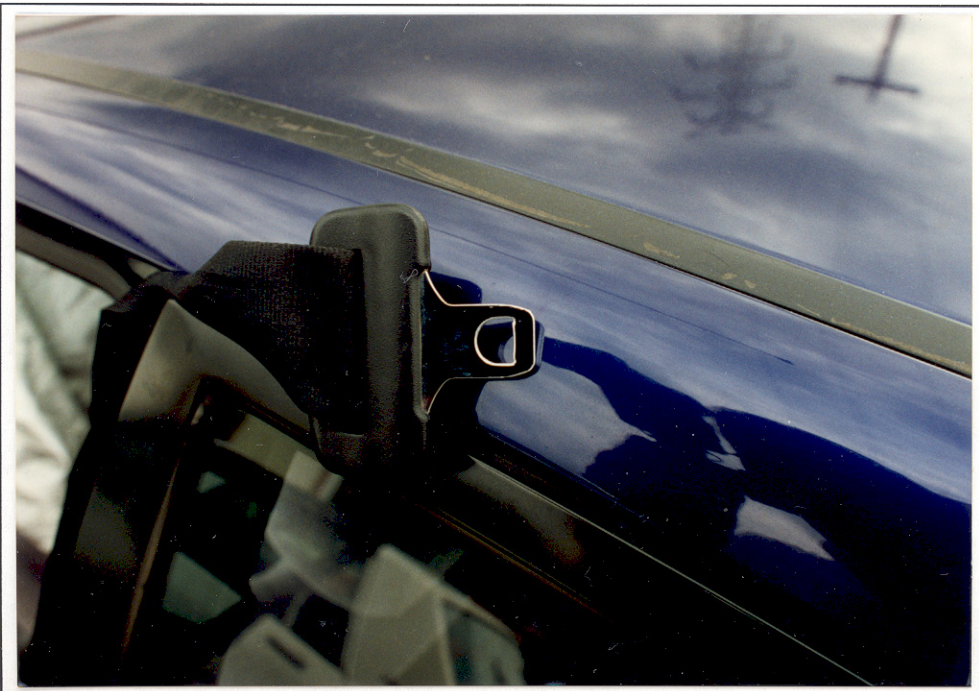
29. View of the left front latch plate depicting infrequent use.

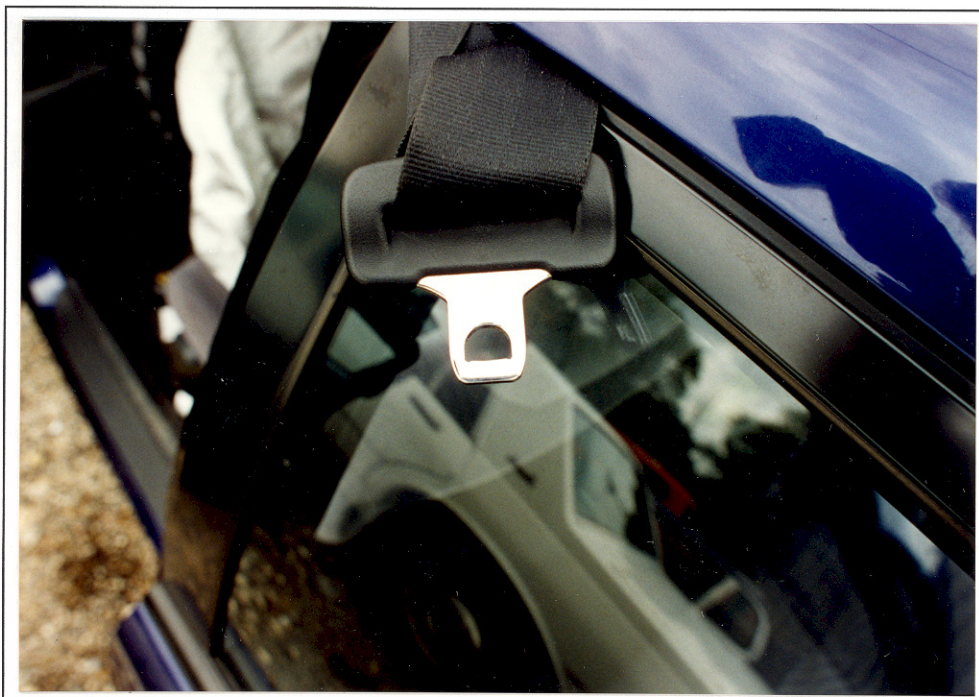
30. View of the left front latch plate (opposite side) depicting infrequent use.

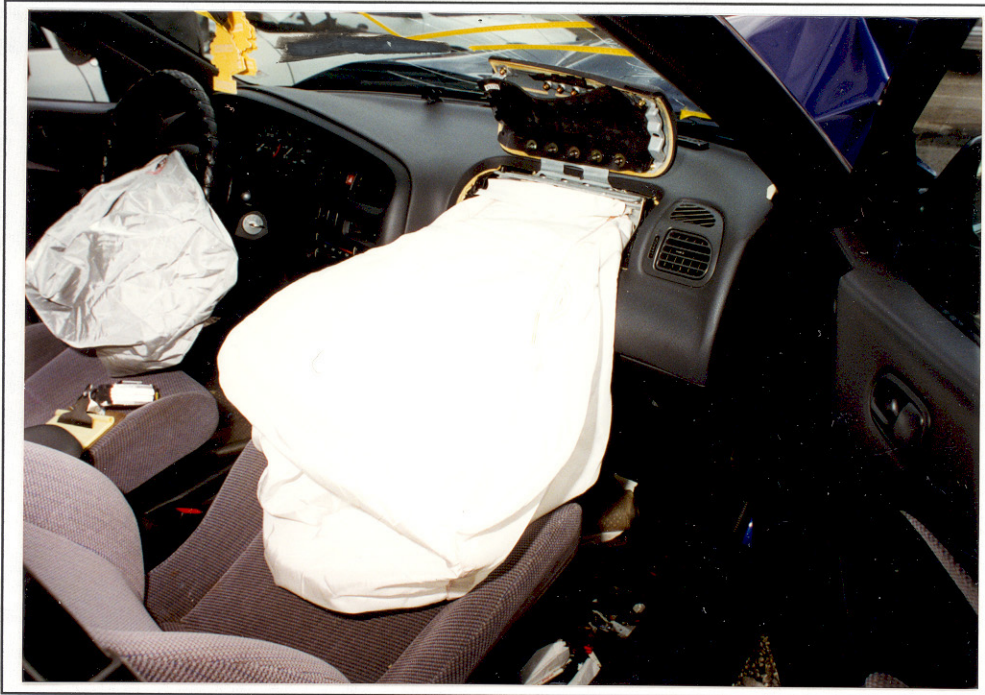
36. View of the right front interior and deployed passenger air bag.

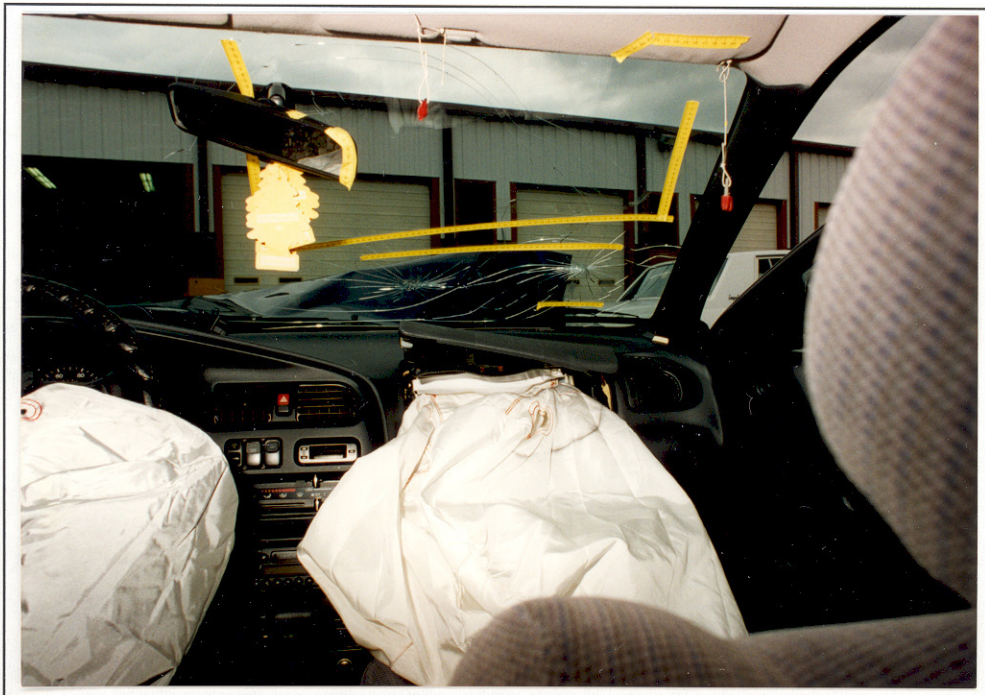
37. Forward view of the right front interior.

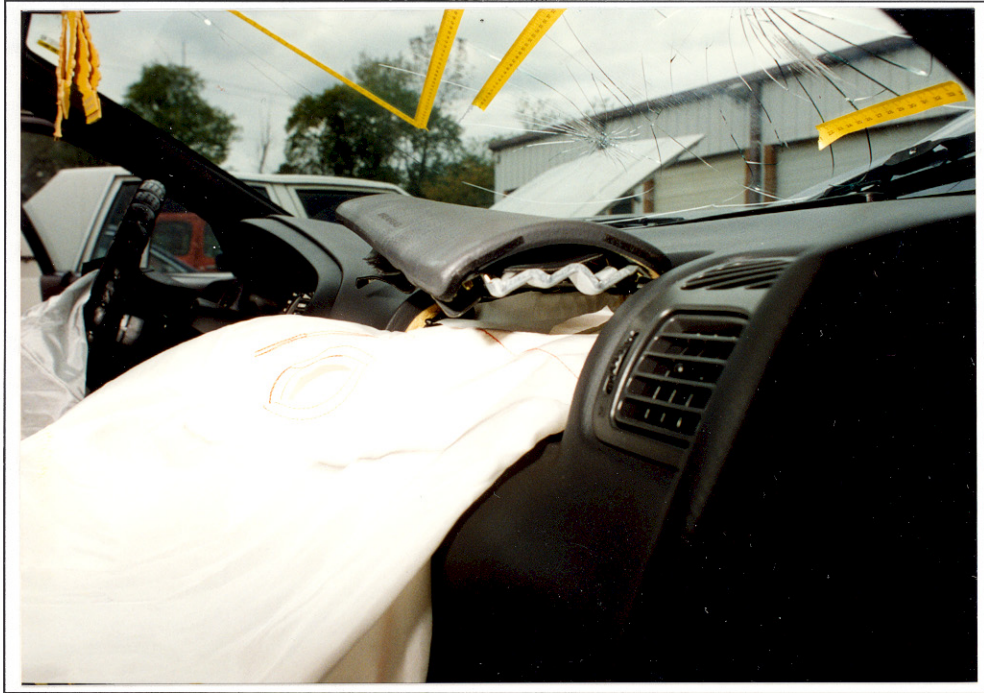
38. Angular view of the deployed passenger air bag and module cover.

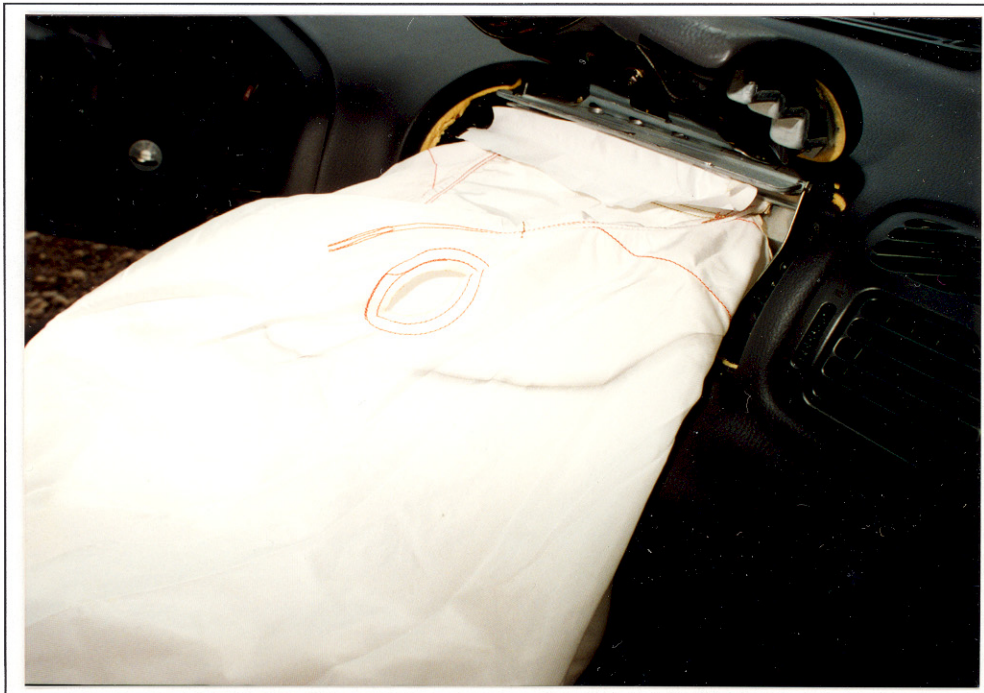
39. View of a black transfer on the right side of the deployed passenger air bag.

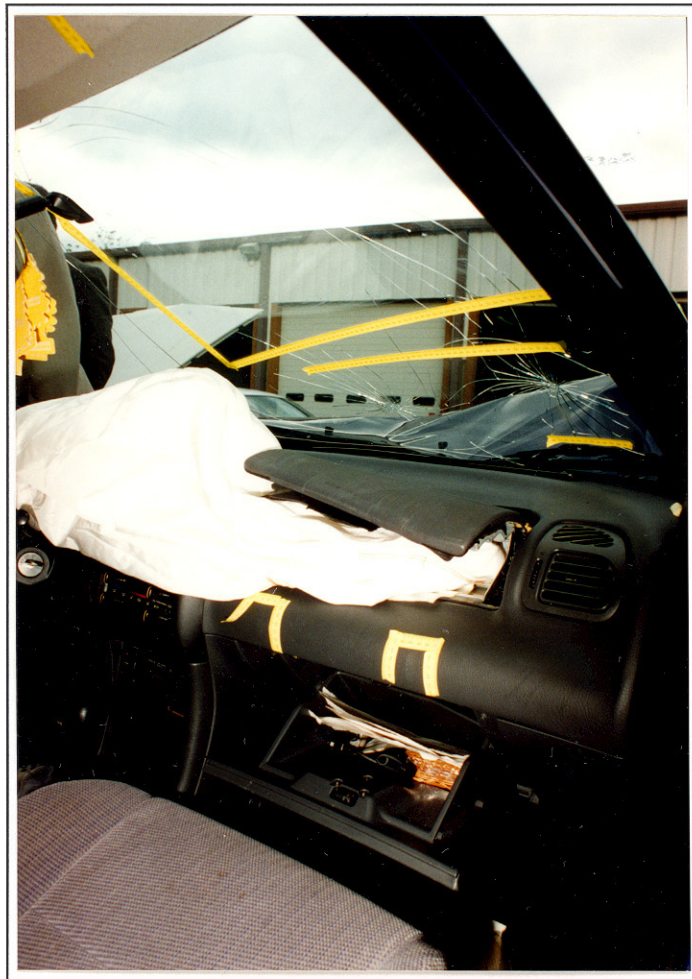
43. Close-up view of the right front interior and contacts.

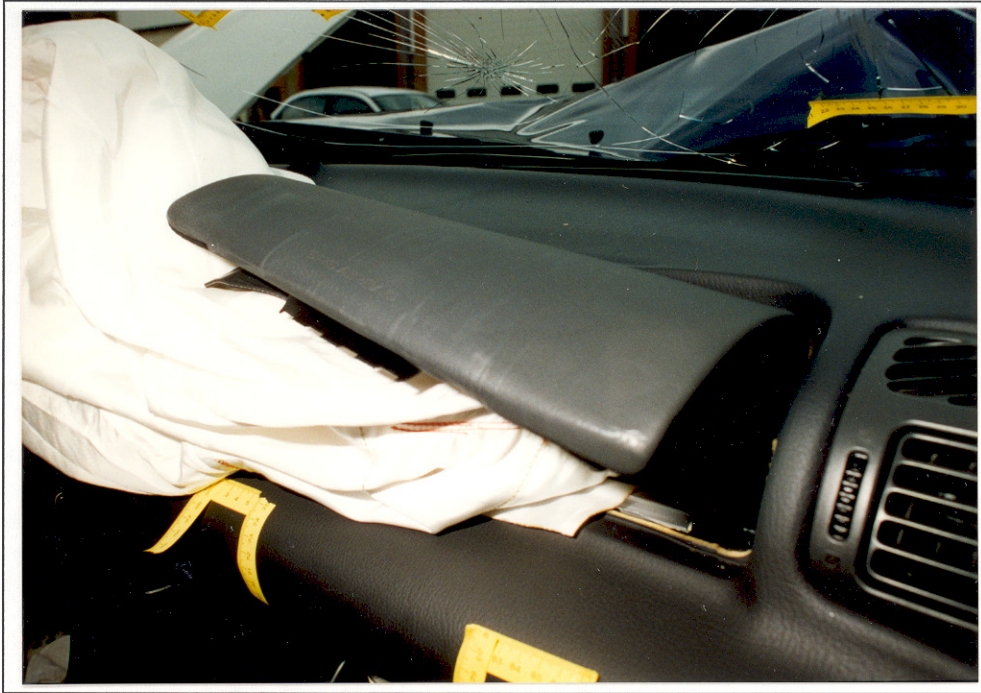
46. View of the deformed passenger side air bag module cover.

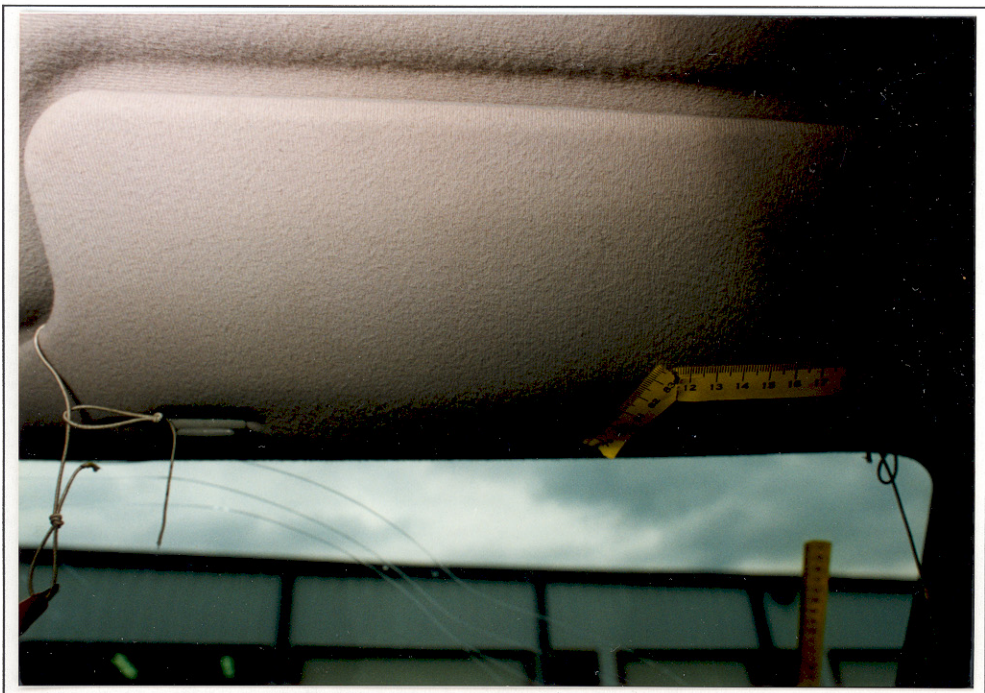
57. View of the stowed right sunvisor and contact to the forward right corner.

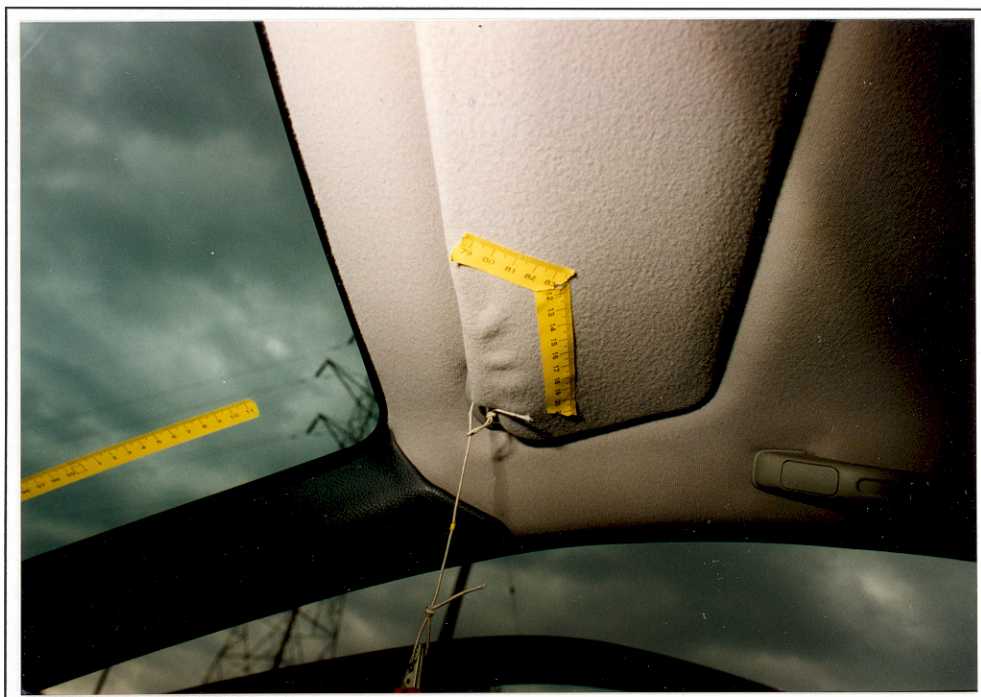
58. Close-up view of the contact to the right sunvisor.

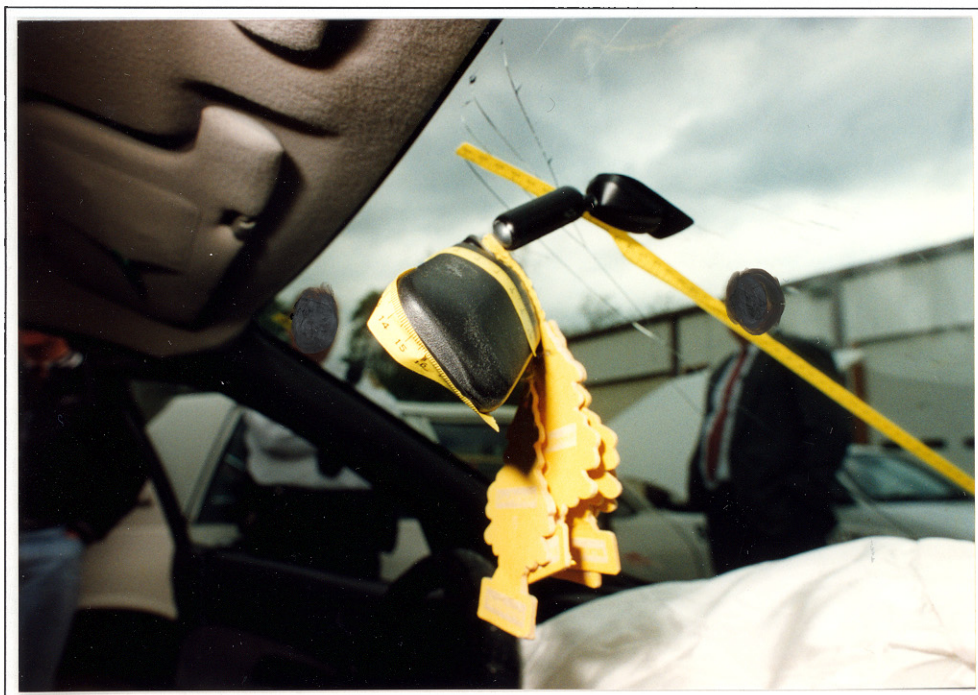
60. View of a transfer on the forward side of the center mirror.

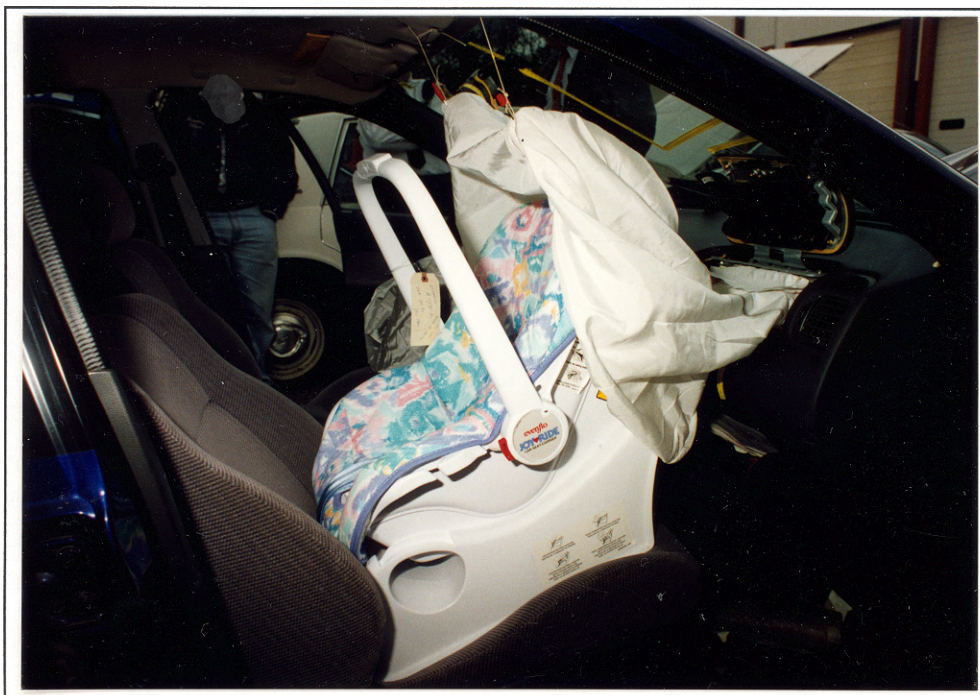
64. Right side view of the child restraint with the air bag in simulated deployment.
